State of California — The Resources Agency
DEPARTMENT OF PARKS AND RECREATION
PRIMARY RECORD

Page 1 of 1 *Resource name(s) or number (assigned by recorder) 471-473 Oak St.

*c. Address: 471-473 Oak St. City: San Francisco Zip: 94102

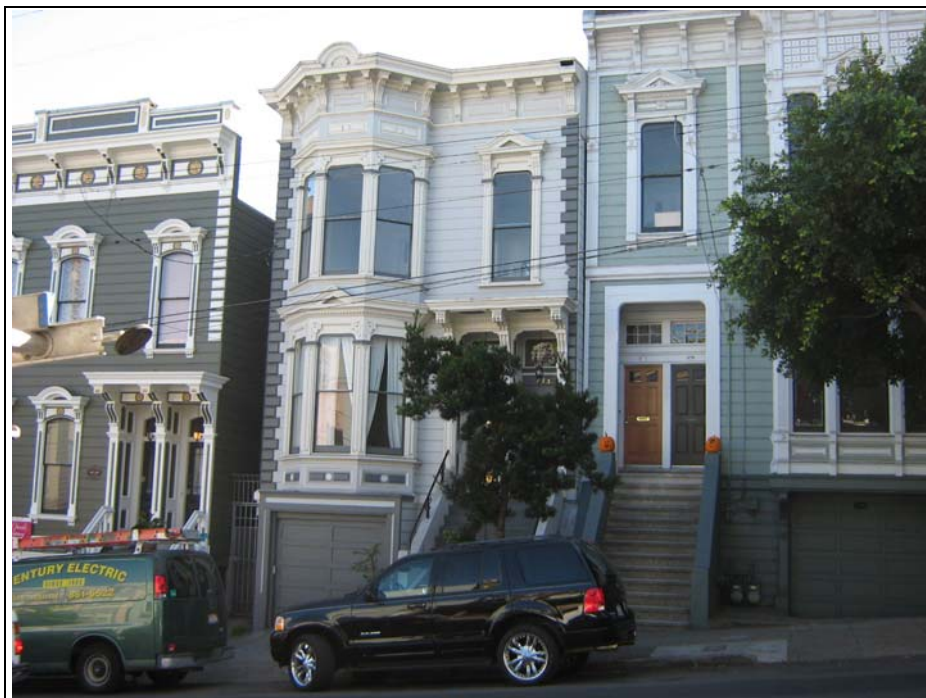
*P5b. Photo: (view and date)

471-473 Oak St. is located on a 26' x 64' lot on the south side of Oak Street, between Laguna and Buchanan Streets. Built circa 1895, 471-473 Oak St is a three-story, wood frame, multiple family building designed in the Stick/Eastlake style. The rectangular-plan building, clad in drop wood siding is capped by a gable roof. The primary façade faces north and is two bays wide. The façade has corner quoins at both ends of the elevation. The basement story features a garage in the left bay with paneled surround and a straight flight of terrazzo steps in the right bay leading to the main entrances on the second story. The main entrances are set within paneled recesses with paneled surrounds and a continuous bracketed door hood. The entrances have modern, paneled wood doors and arched transoms. The left bay contains a semi-hexagonal bay window with paneled spandrels; double-hung, arched wood sash windows; and paneled surrounds with flat, scroll-sawn brackets. The window ends in an intermediary cornice with pediment over the central window. The third story has a similar bay window in the left bay with a plain cornice line. The right bay of the third story has a single double-hung, arched wood window with pilaster surround and bracketed pediment hood. The elevation terminates in a paneled frieze and a bracketed modillion cornice. A small arched pediment is set above the center of the left bay. The building appears to be in good condition.

View from north
10/27/2006
