State of California — The Resources Agency
DEPARTMENT OF PARKS AND RECREATION
PRIMARY RECORD

Page 1 of 1 *Resource name(s) or number (assigned by recorder) 133 McCoppin St.

Page 1 of 1 *Resource name(s) or number (assigned by recorder) 12 Elgin Park

BUILDING, STRUCTURE, AND OBJECT RECORD

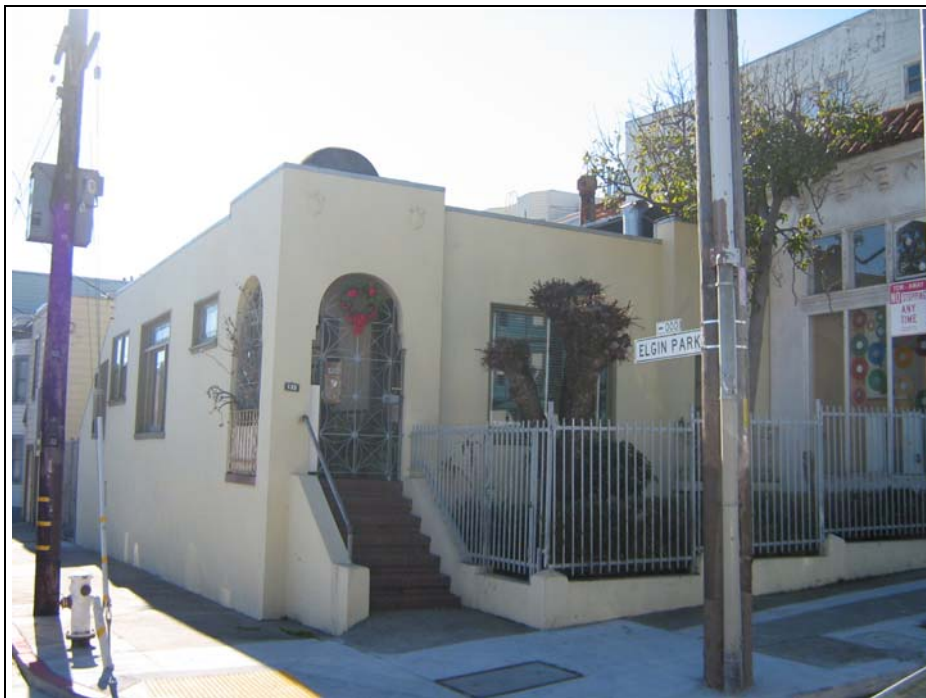
133 McCoppin Street is one of four buildings located on a wedge-shaped corner lot on the south side of Market Street between Elgin Park and Pearl Street. It shares the lot with 1795-1797 Market St., 1801 Market St., and 12 Elgin Park. Constructed in 1925 and designed in the Mediterranean Revival style 133 McCoppin Street is a 1-story, wood frame, residential building. The building has a rectangular-shaped plan, stucco cladding, and a flat, parapeted roof. The primary elevation is 3 bays wide and is oriented north towards Market Street. The first floor features the main entrance in the right bay, sheltered by an entry porch with arched openings, decorative metal gates, cartouche ornament, and dome above the entry portico. The building has a wood door. The remaining bays have a wood-frame picture window and fixed divided wood window. A secondary elevation on Elgin Park has an art glass awning window; three-part, wood-frame window with art glass transom; and paired, double-hung sash. The property has a service porch clad in composite wood siding on the rear elevation. All elevations end in plain rooflines. The property appears to be in good condition.

P5b. Photo: (view and date)
View from north
1/5/2007

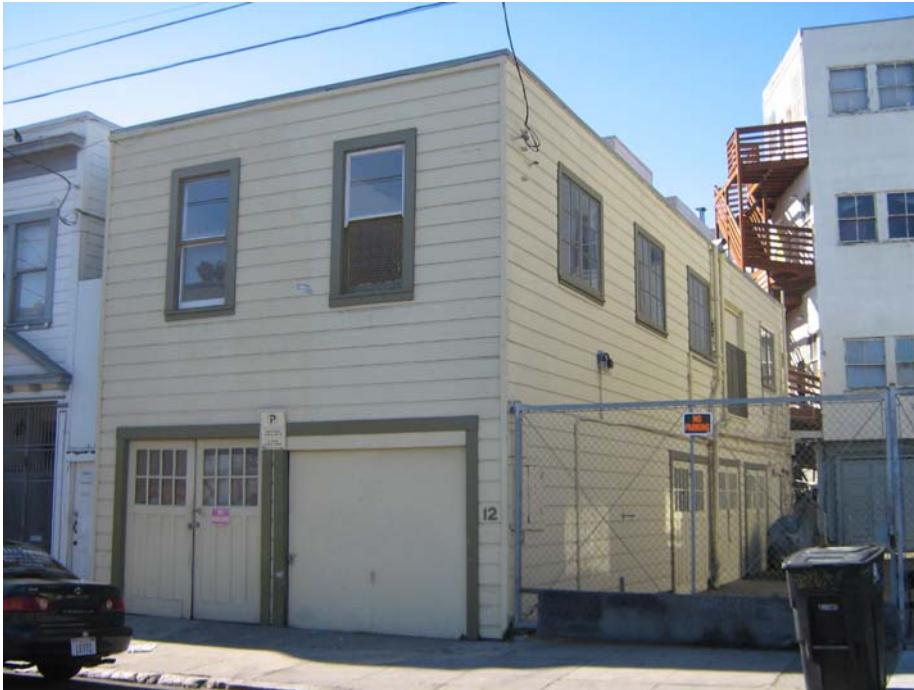
12 Elgin Park is one of four buildings located on a wedge-shaped corner lot on the south side of Market Street between Elgin Park and Pearl Street. It shares the lot with 1795-1797 Market St., 1801 Market St., and 133 McCoppin St. Constructed ca. 1925 12 Elgin Park is a 2-story, wood frame, ancillary building. The building has a rectangular-shaped plan, drop wood cladding, and a flat, parapeted roof. The primary elevation is 2 bays wide and is oriented east towards Elgin Park. The first floor features two automobile openings with a double-leaf, paneled and glazed wood doors and a modern overhead door. The upper story has a double-hung, wood window in each bay. A secondary elevation faces north toward the interior of the lot. The first story has three automobile openings with double-leaf, paneled and glazed, wood doors. The upper story has divided wood casement sash and a sealed bay opening with metal banister. All elevations end in plain rooflines. The property appears to be in good condition.

P5b. Photo: (view and date)

View from east
