PRIMARY RECORD

Resource Name or #: (Assigned by recorder) 2000 - 2016 FILLMORE ST

c. Address: 2000 - 2016 FILLMORE STREET City: San Francisco ZIP 94115

Japantown Better Neighborhood Plan

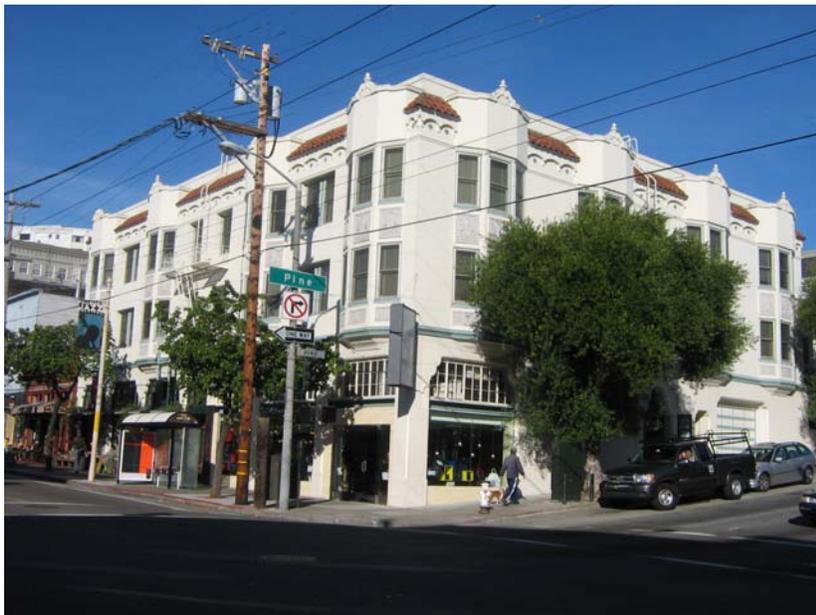
P5a. Photo

2000 - 2016 Fillmore Street is located on a 87.5' x 81' lot on the northeast corner of Fillmore and Pine streets. Built in 1928, 2000 - 2016 Fillmore Street is a 3-story with mezzanine, wood frame, mixed use building designed in the Mediterranean Revival style. The rectangular-plan building, clad in scored stucco, is capped by a flat roof. The foundation is concrete. An integral garage is located on the east side of the south façade at the first story level.

The primary façade faces west. The building features 2 commercial units with 2 commercial entrances on the first floor, and 14 residential units above with 1 residential entrance on the first floor. Seven structural bays make up the storefront level. The commercial entries are located at the north and south sides of the primary façade on Fillmore Street, and feature a partially glazed wood door and a glass door, respectively. The storefront of the northern commercial unit consists of fixed, plate glass in wood sashes with metal framed glass awnings above; multi-light, fixed, wood sash clerestory windows with spindled mullions and stained glass are located at the top of each structural bay.(continued)

View of the primary façade, looking northeast. 11/14/2007

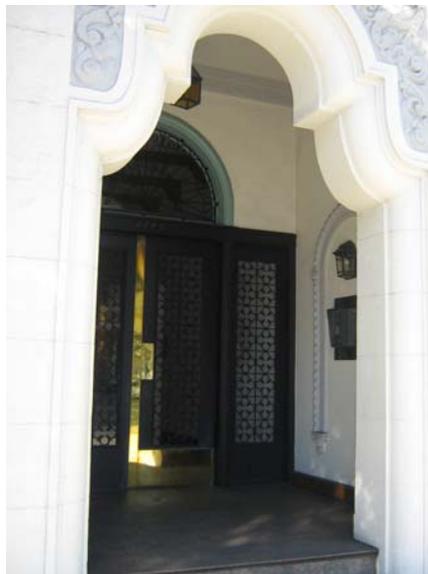
The south facade features the residential entry to the building. The residential units are accessed by fully glazed, wood double doors with molded trim, side lights, and a glazed fanlight. The recessed entry has an elaborately shaped, arched opening and features tiled flooring, arched wall moldings and patterned grillwork on the door, fanlight, and side lights. Elaborately sculpted spandrel panels are located above the arched opening. The ornamentation described on the primary, Fillmore Street facade continues on the secondary facade, which includes four angled bay windows. A storefront window for the southernmost commercial unit is located at the west side of the south facade and a secondary entry, consisting of a partially-glazed, paneled, wood door within a recessed vestibule is located between the residential entry and integral garage.

The building appears to be in good condition.

Detail of the residential entry on the south facade, looking northeast.
Source: Page and Turnbull
